Standarduster

DECEMBER 1987

NOTICE TO ALL STARDUSTER TOO OWNERS AND BUILDERS

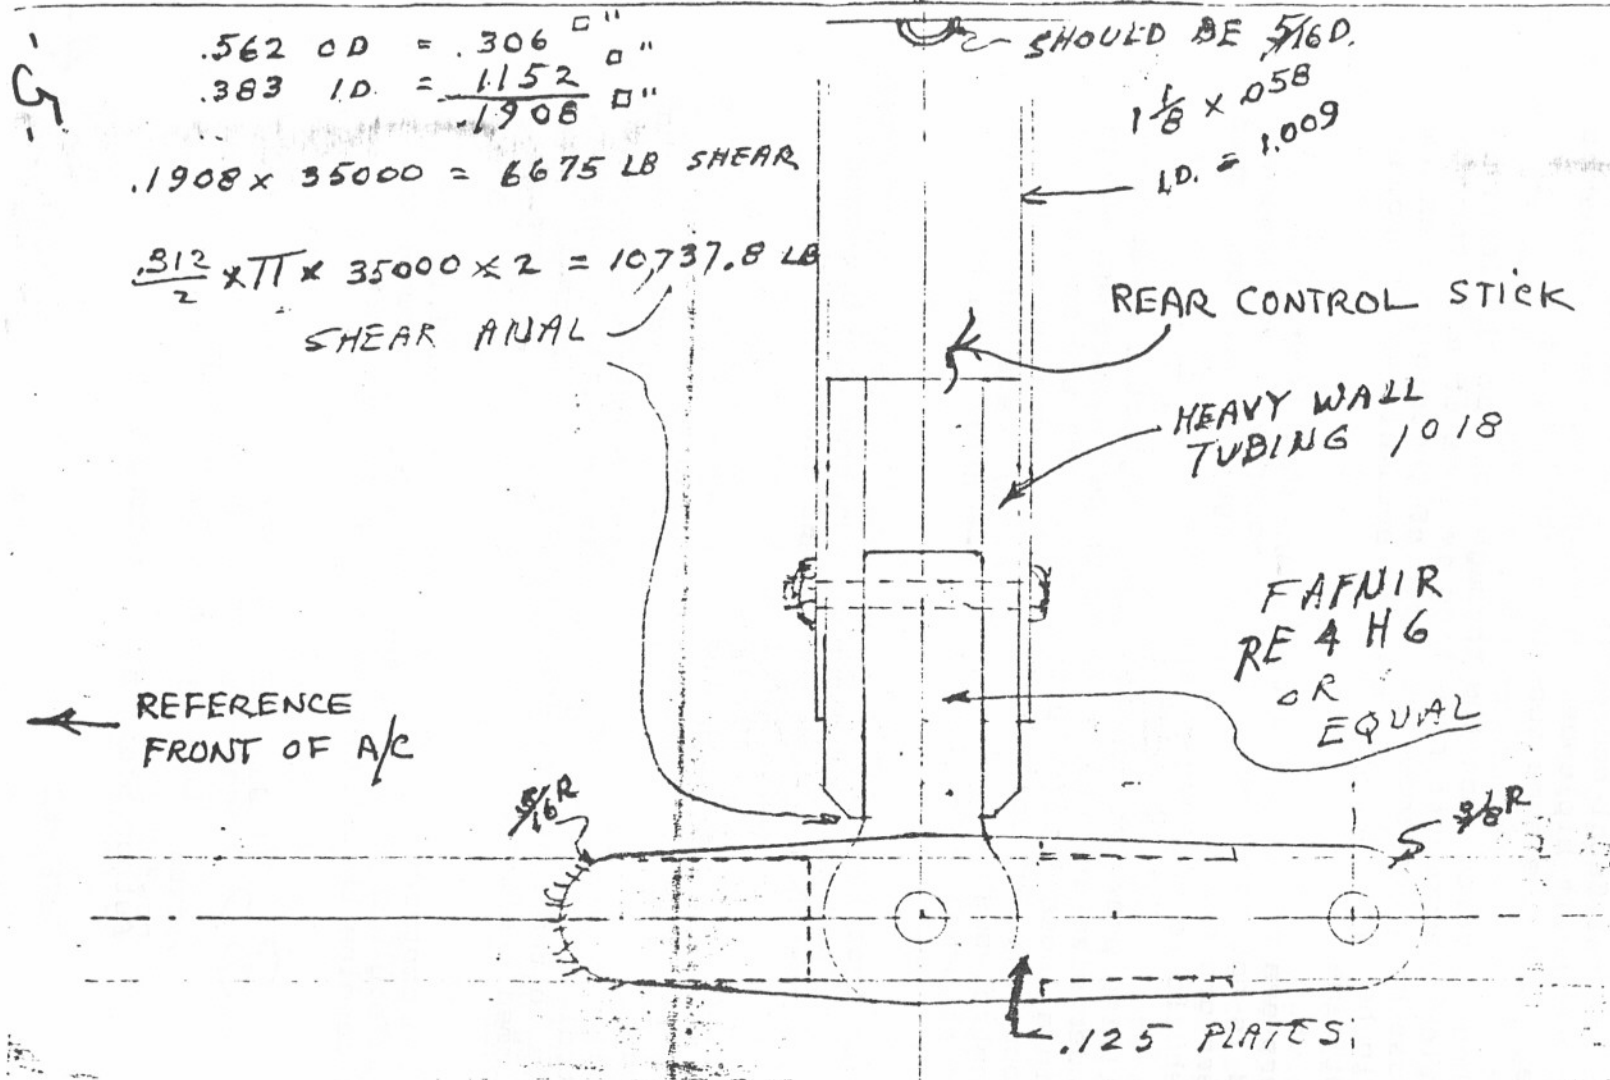
MODIFICATION Made ON STARDUSTER TOO NH22NS
STICK TO STICK Rod connects
BY THOMAS NEMYO
21861 SHERWOOD DR.
FAIRVIEW PARK OHIO 44126
(216) 734-4594

Investigation has revealed that the through bolt at the lower rear control stick sheared off resulting in loss of elevator control. It must be understood that both of these airplanes had been involved in heavy aerobatics and had accumulated numerous hours of flight time.

During the building proccess many builders neglected to drill these holes under size and ream them to proper dimension, which would result in a loose fitting bolt. Operating the control system with loose fitting bolts, elongated or worn holes, and misaligned control push-pull tube and control reverser results in a sawing or abnormal wear pattern. thus after many hours of use could fail.

.562 OD = .306" □"
.383 ID = 1.152" □"
1.908

.1908 x 35000 = 6675 LB SHEAR

$\frac{.312}{2} \times \pi \times 35000 \times 2 = 10737.8 \text{ LB}$
SHEAR ANAL

It is my recomendation that when the airplane is first bulit that all control system hole dimensions be drilled under size and reamed to proper bolt size. It is further my recomendation that all aircraft in service at this time be inspected to insure that bolts in control system are in good condition and show no wear, and that bolts in the stick to stick to control push-pull tube to reverser be immediately removed and checked for any signs of wear.
