Starduster

APRIL 1993

STOLP STARDUSTER CORPORATION

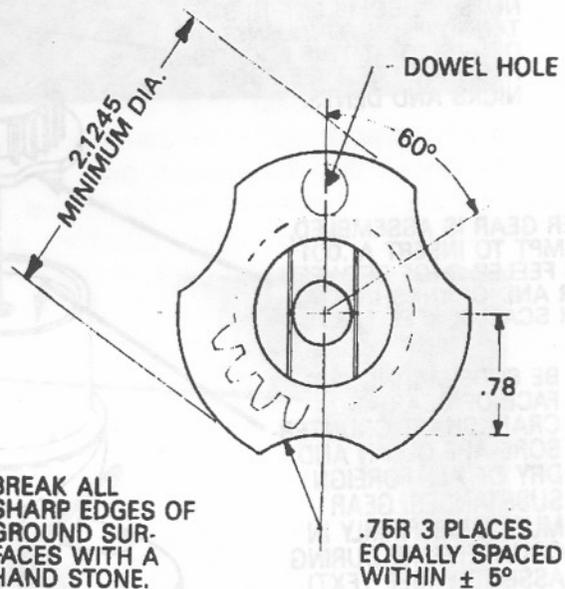
Figure 5. Details for Modification of Crankshaft Gear to Provide Means for Inspection

Crankshaft gears for applicable engines are now manufactured with three 3/4 inch radius scallops cut into the O.D. of the pilot flange. These enlarged scallops have been added to allow inspection of the gear and crankshaft assembly. Serviceable gears must be modified as shown in Figure 5, prior to being reassembled on the crankshaft, or a new gear that has been manufactured to this configuration must be installed. Before modifying the gear, measure the diameter of the

(5) Verify that the crankshaft gear incorporates three .75 inch radius scallops on the flange as shown in Figure 5 of Textron Lycoming SB No. 475, Revision A, dated July 16, 1990. Assemble gear onto crankshaft using a new retaining bolt and lockplate and insure fit of mating parts as described in Section 6 and Figure 6 of the Textron Lycoming Service Bulletin No. 475, Revision A, dated July 16, 1990.

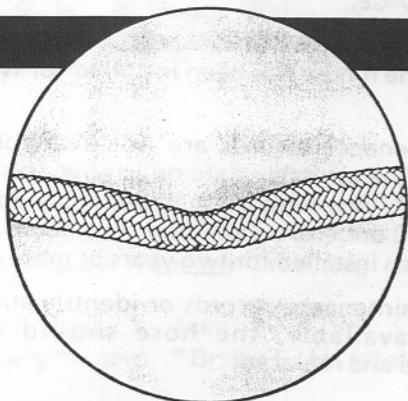
Kinked Hose

Usually is a result of Teflon* hose being improperly handled. Fluid flow is reduced. A break is in the making.

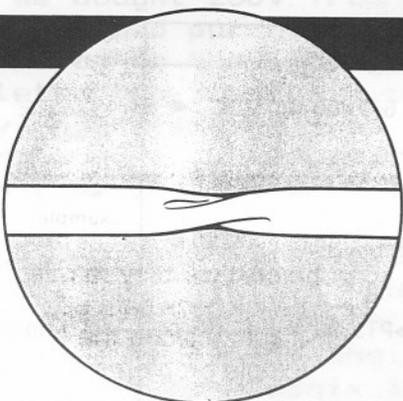
Twisted Hose

Incorrectly installed, easy to spot. Flow is cut down. If the hose is permanently deformed, replace it at once.

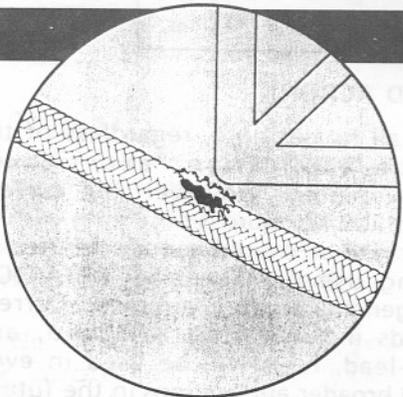
Scuffed Hose

Results from abrasion against a frame, an engine component, or another hose, or from incorrect clamping. Hard to detect on unsleeved wire-braided hose. Sleeved hoses usually exhibit evidence of wear if this problem is present.

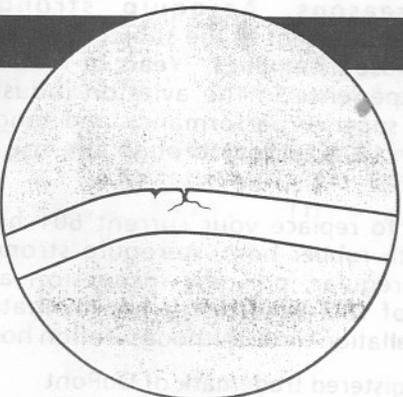
Brittle Hose

Rubber hose that's hardened, no longer flexible. Feel for stiffness. Wiggle and listen for crackling. Temperature and time produce this effect. Be sure you have the correct type of hose for the application.

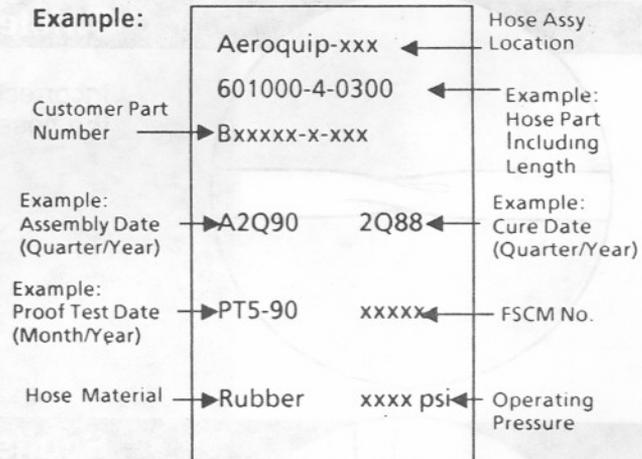
Example:

- I. Review maintenance log books to determine if hose has been installed for two years.
- II. If maintenance records are not available, refer to the assembly date quarter/year (see example). Any hose with an assembly date of A4Q90 or before should be considered to have been installed for two years or more.
- III. If no maintenance records or identification tag is available, the hose should be removed and replaced.

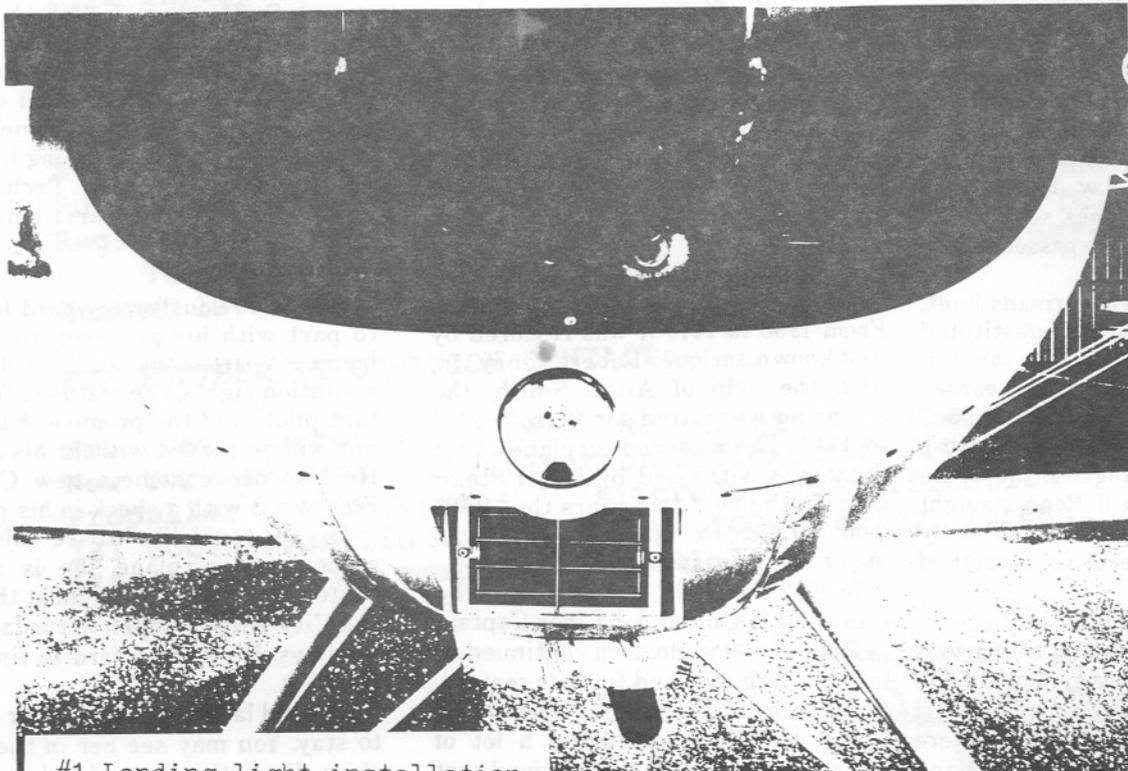
#1 Landing light installation

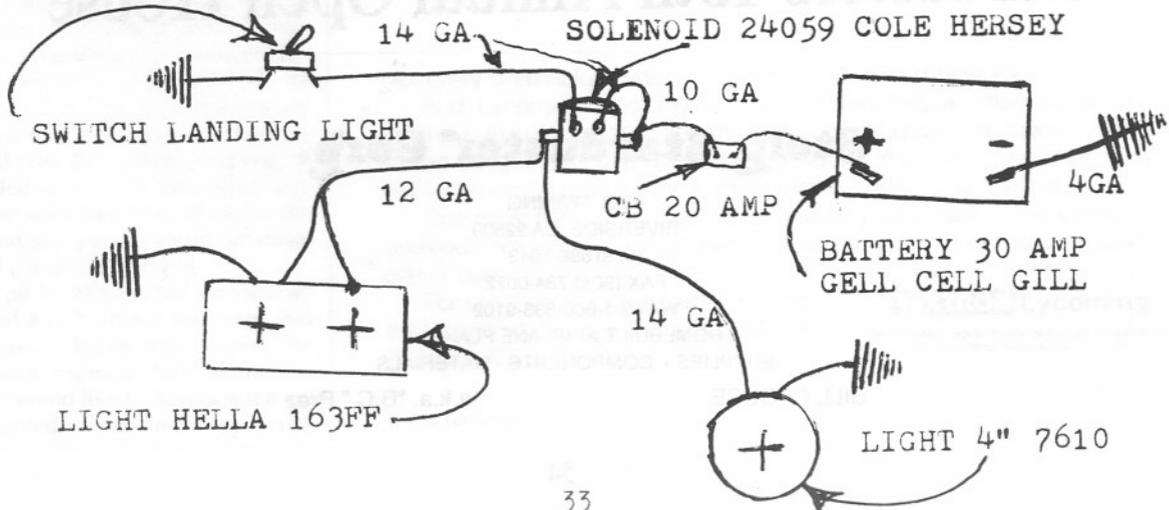
If multiple lighting of more than 10 amps is being installed, a constant duty relay/solenoid should be used. I recommend the Cole Hersey #24059, they list for around \$12.00 and draw .8 tenths of an amp. The nice thing about them is that they are a four pole relay and can use either 12 volts or ground to initiate them. A schematics chart and parts list are included with this article.

Light Halogen AS163FF with "C" pattern made by Hella has two 55 watt bulbs heavy equipment work light. Approximately : \$70.00

Cole Hersey constant duty relay #24059 4 pole and can be made by grounding the unit or by 12 volts. This unit can also be used for a master switch or a starter solenoid. Approxiamtely : \$12.00
