Starduster

MAGAZINE

APRIL 1994

TABLE OF CONTENTS

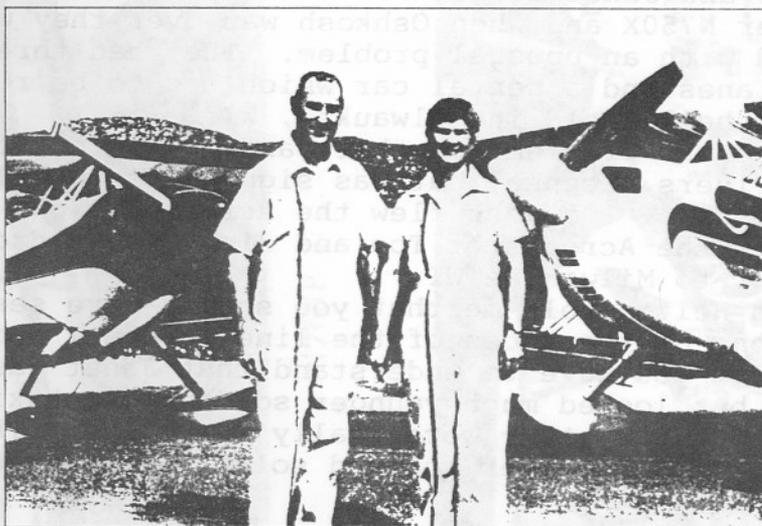
**CHRISTEN EAGLE II
SPECIFICATIONS**

Engine	200 H.P. Lycoming
Length	17 ft. 9 in.
Wingspan	19 ft. 11 in.
Empty Weight	1050 lbs.
Fuel Capacity	25 gal.
Top Speed	184 MPH
Cruise Speed	165 MPH
Landing Speed	65 MPH
Structural Limits	+9G -6G

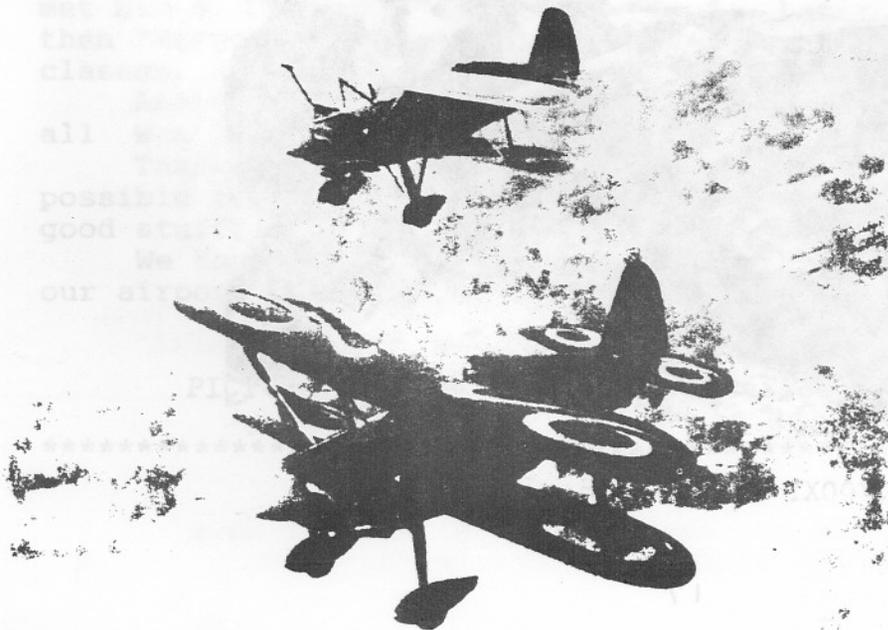
N700XP FLYING IN FOR-
MATION WITH N750X, OUR
ACRODUSTER TOO

BOTH MACHINES HAVE THE
LYCOMING IO-540 200hp
ENGINES-

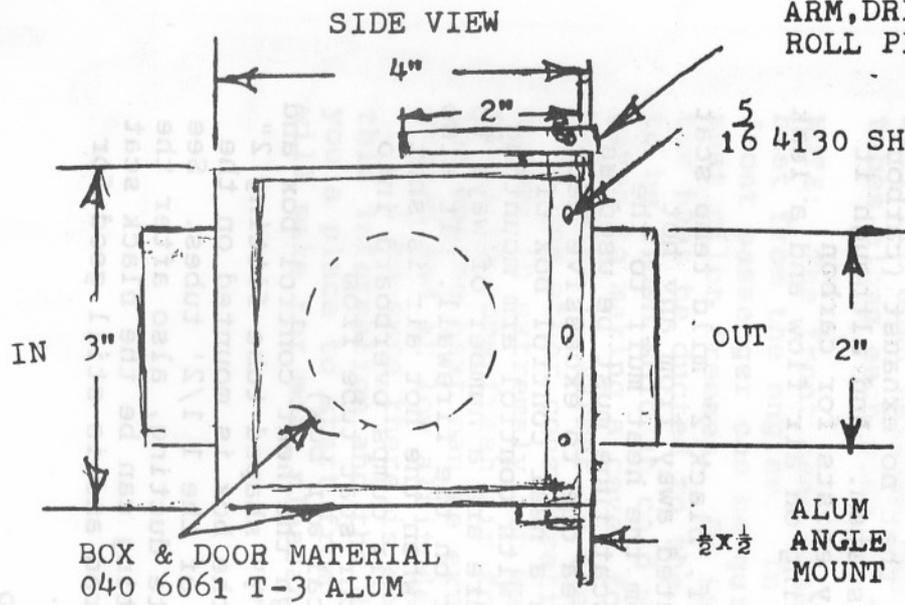
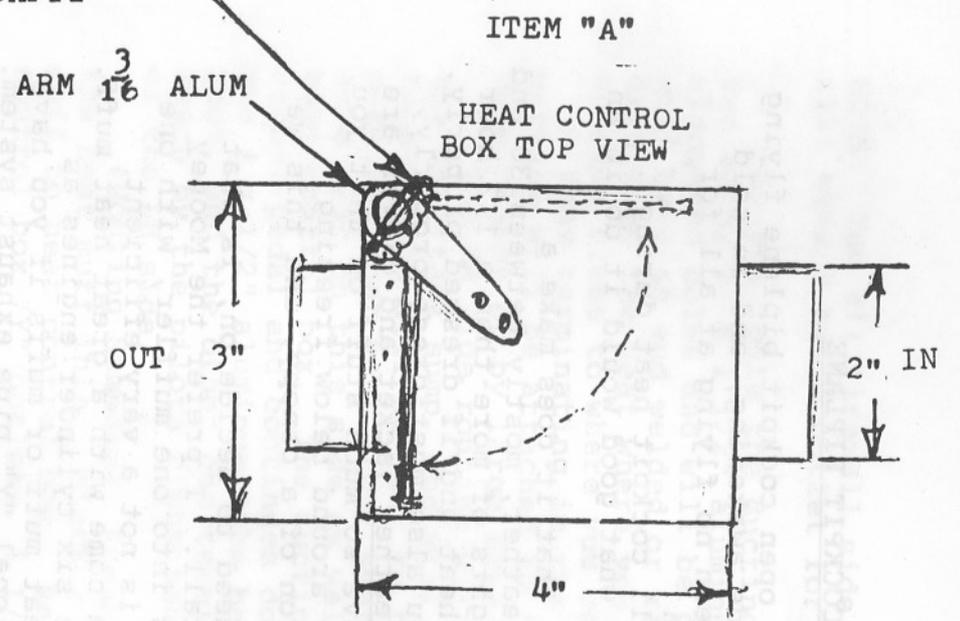
HEAT CONTROL BOX ITEM "A"

After the heat travels through the heat control box and firewall you will need to make a "Y" shaped tube fitting 2" in with 2 1 1/2" outlets. Where the box is mounted on the firewall will dictate the routing of the 1 1/2' tubes. See drawing for details of how to route ducting, also after the heat control box. The 1 1/2" ducting can be the black scat tubing as it is cheaper than the red and is still good for approximately 300 degrees of heat.

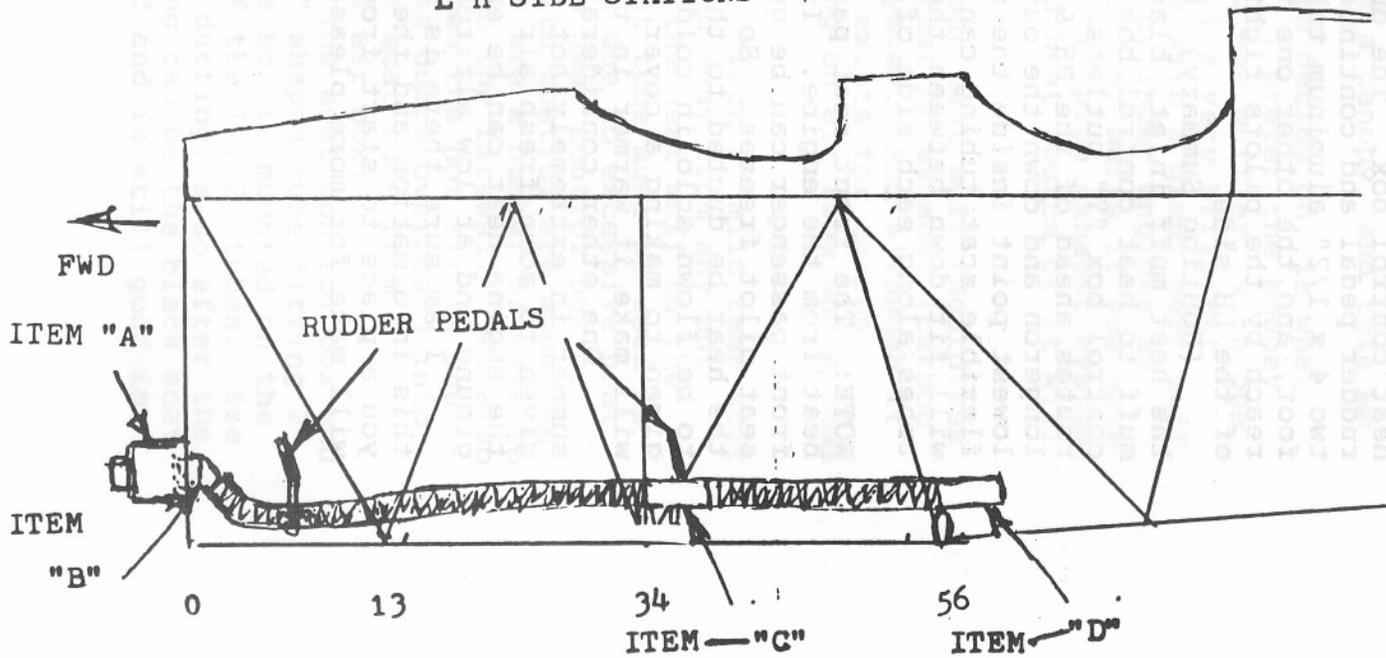
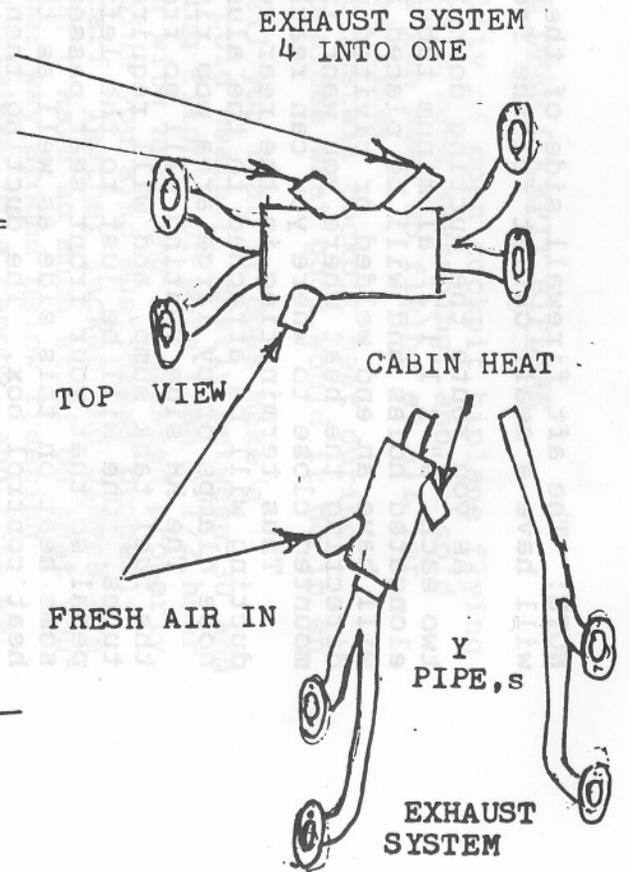
VIEW DUCTING LOWER L H SIDE STATIONS

NOTE: The aft firewall side of the heat control box outlet will have a small outlet for the front seat passenger.

As you route the ducting down the LH side you will need two each, 4" x 1 1/2" aluminum tubes. One will have several elongated holes and will be placed at your feet. The other will have an end welded or riveted with several holes directing the heat where you want it to go and this can be mounted close to where you can reach it to warm your hands.
