# *Starduster*

MAGAZINE

**April**  
**1995**

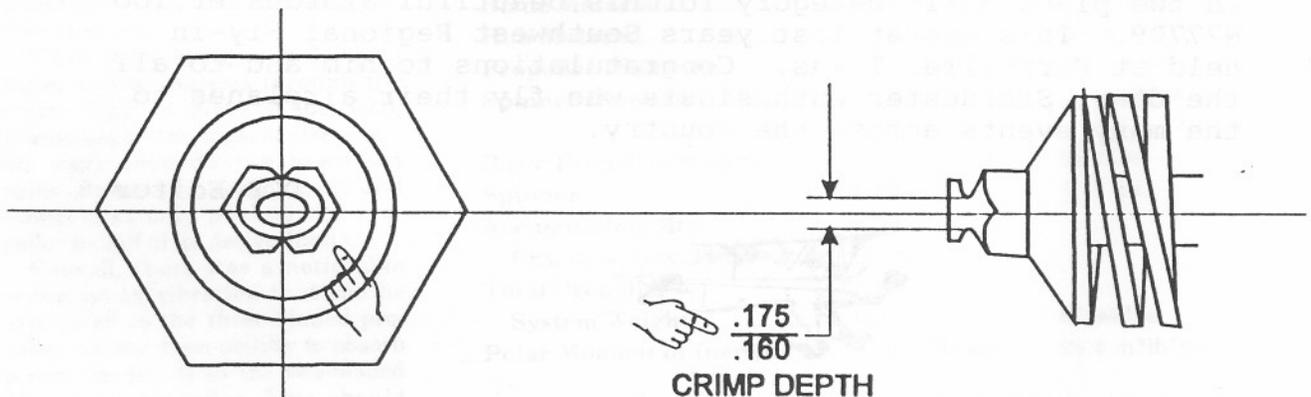
Step 1 is the dimensional inspection of the crimp nut. The crimp depth on the nut must be .160-.175 as shown in Figure 1.

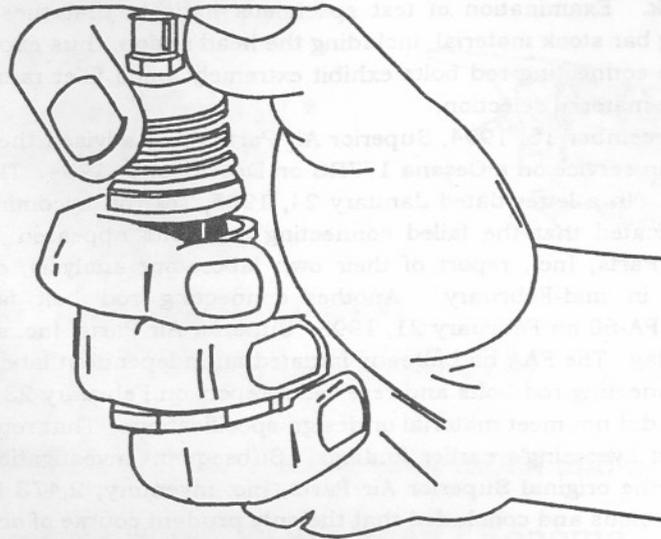
Figure 2.

Step 2 is the physical inspection of the crimp nut to ensure it is seated and solid on the shaft. Separate the seat and retaining nut by holding the valve assembly in one hand and compressing the valve spring with the forefinger and thumb. (See Figure 2.) With the seat and nut separated, grasp the crimp nut with the other hand and attempt to move it. The crimp nut must not move.

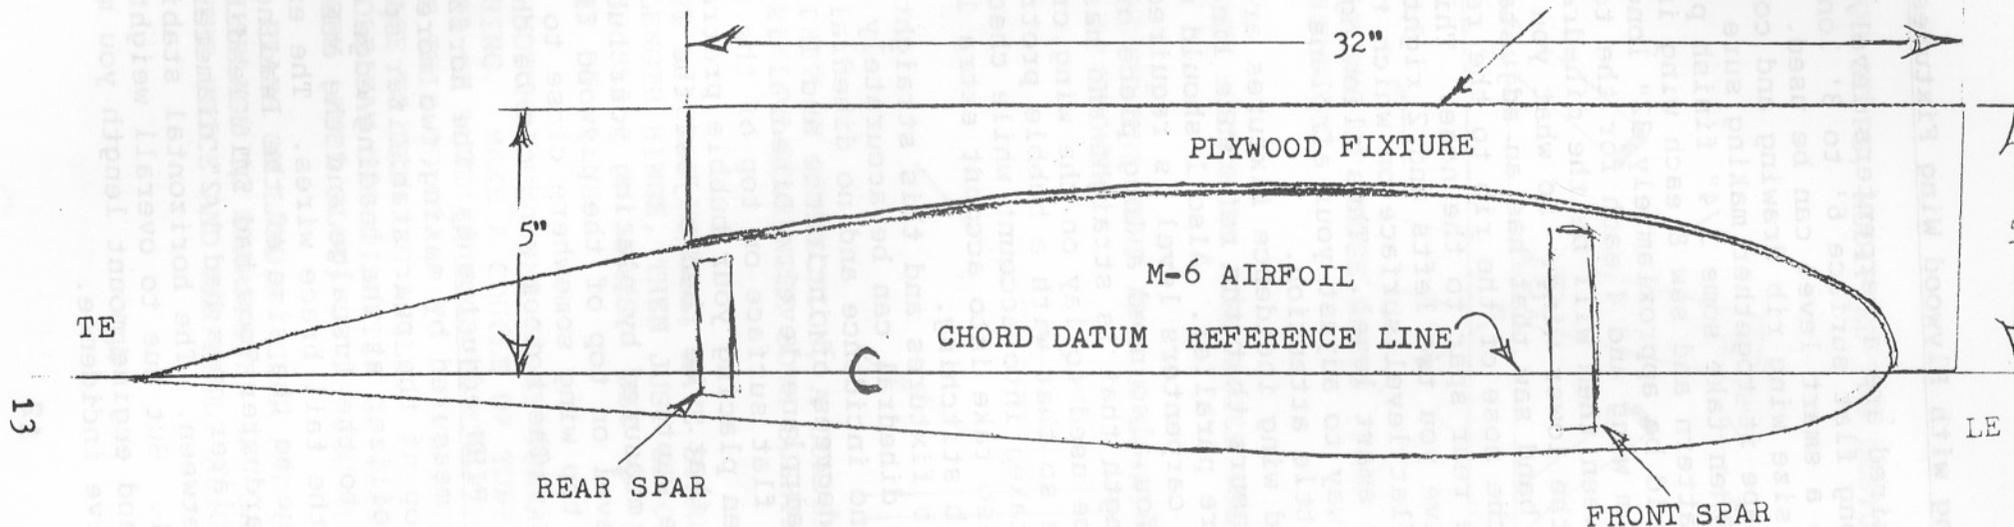
PLYWOOD WING RIGGING FIXTURE

LEVEL SURFACE

4EA UPPER WING 4EA LOWER WING  
 LOWER WING REQUIRES 2LEFTS AND  
 2RIGHTS TAKING INTO ACCOUNT THE  
 1½ DEGREES OF DIHEDRAL

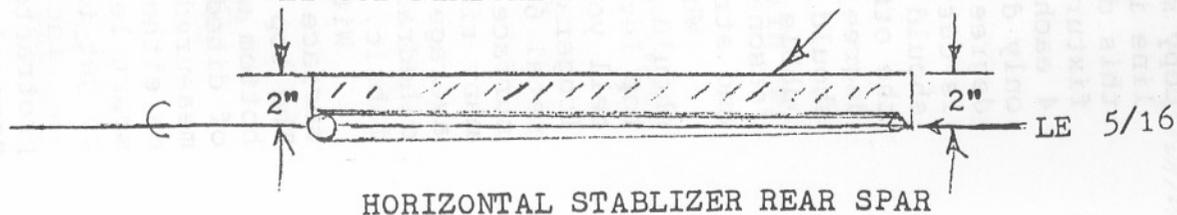
PLYWOOD FIXTURE

LEVEL SURFACE

HORIZONTAL STABLIZER REAR SPAR

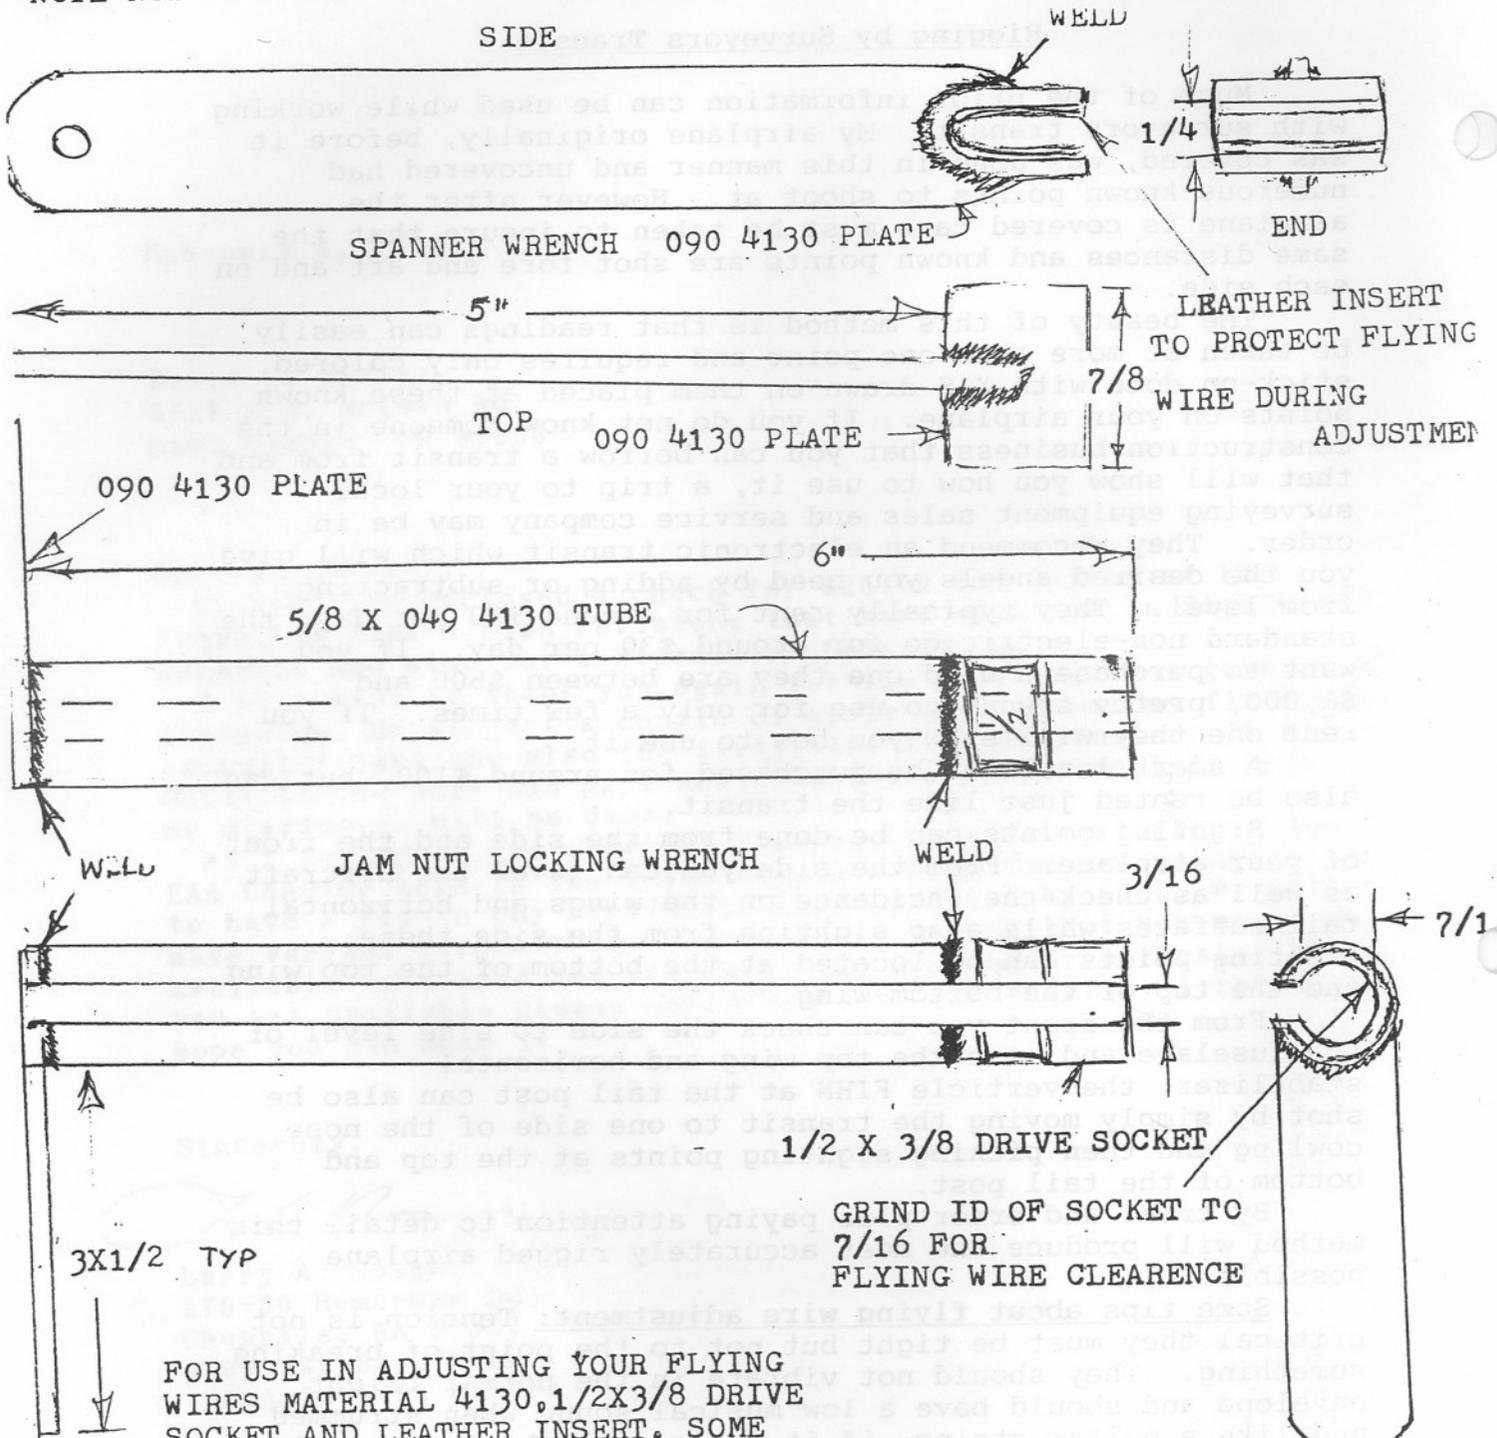
NOTE NOT TO SCALE

FOR USE IN ADJUSTING YOUR FLYING WIRES MATERIAL 4130, 1/2X3/8 DRIVE SOCKET, AND LEATHER INSERT. SOME CUT AND FIT TRIAL AND ERROR MAY BE REQUIRED TO INSURE THE CORRECT

FIT AND DIMENSIONS

Several tools can be made to help in adjusting flying wires, one is a small spanner wrench that is made out of 4130 plate it slips over the wire to hold or ajust it while tightning and loosening wires or jam nuts. The other tool is used for tightning and loosening the jam nuts on the lower inboard wing wires that go thru the wing walk. Many times the inspection hole is not big enough to get your hand and wrenches in to loosen these nuts.

So a tool to do this can be made by using a 1/2" socket by 3/8 drive and 6" piece of 5/8" OD 4130 tubing, welding the socket to one end of the tubing and the handle to the other, plus cutting a groove down the entire length so that it will fit over the flying wire and then can be pushed down into the flying wire hole to either tighten or loosen the jam nut. These tools will help in wire adjustments and are shown in detail elsewhere in the article. So have fun and fly straight and fast.

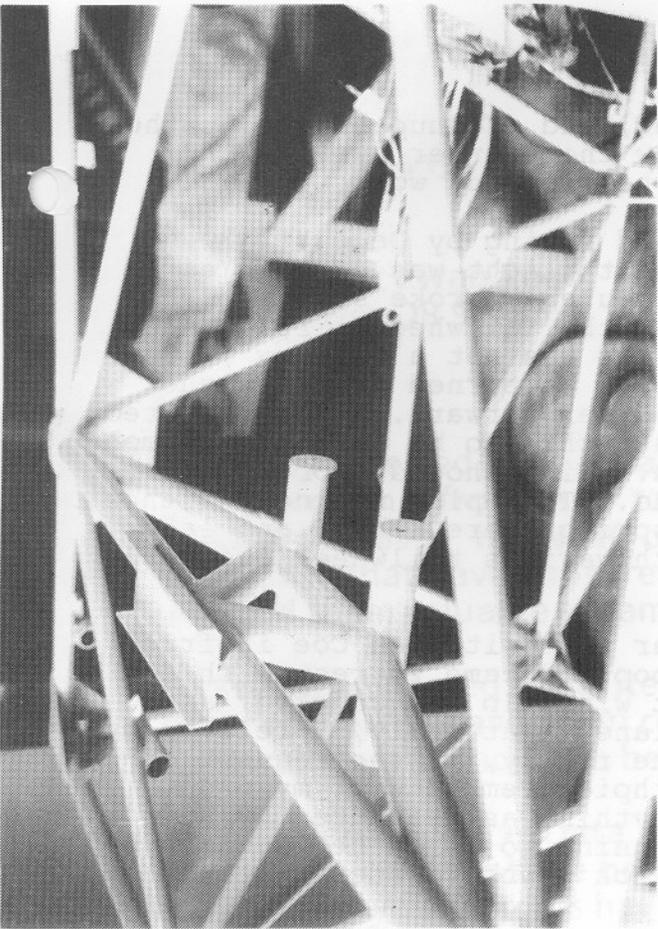
NEW GEAR TRUSS AND MCDS

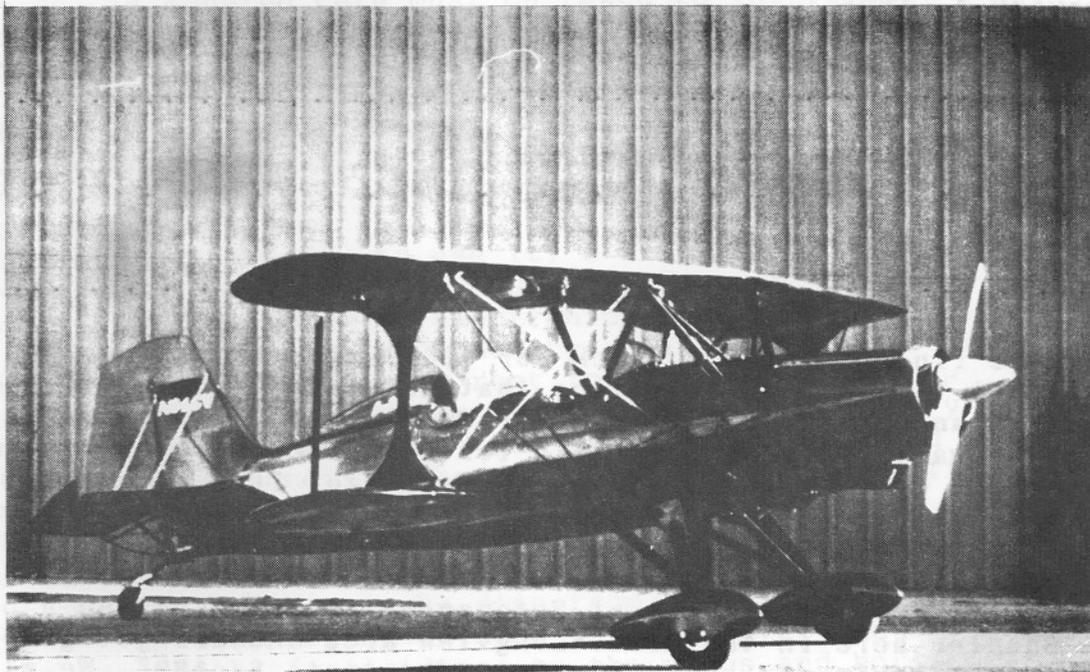
Above: Starduster Too, N94GV

engine : Lycoming O-320 , 150 hp.  
weight : 1124# empty  
panel : very basic, no radios  
airspeed : 115-120 mph cruise

prop: Sensenich 74 - 56  
paint : Black Dupont Imoron  
fuel cap: 40 gals.  
stall speed: 52 mph / power off

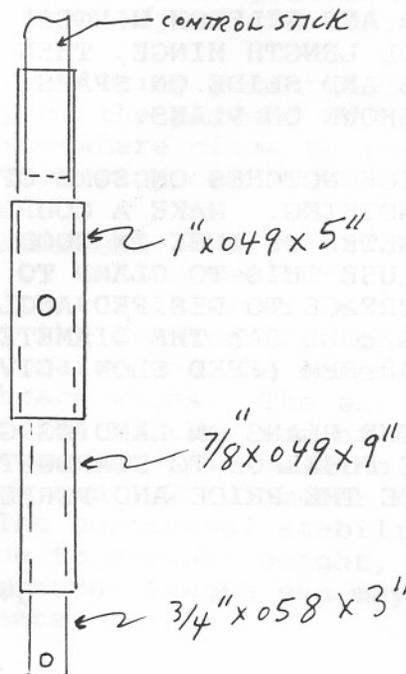
5. SQUARE VS ROUND TUBE WORKS REAL NICE IN A FEW PLACES. THE FLAT SIDES ARE EASY TO WORK WITH ON DRILL PRESSES AND MITER ANGLES AND EASIER TO JIG. ONE AREA I WISH I HAD USED RECTANGULAR TUBE WAS THE CARRY THROUGHS. COULD APPLY TO RUDDER PEDALS ALSO. ONE AREA I WAS CONCERNED ABOUT GETTING THINGS SQUARE AND TRUE WAS THE CONTROL STICKS. USED THE FOLLOWING SCHEME:

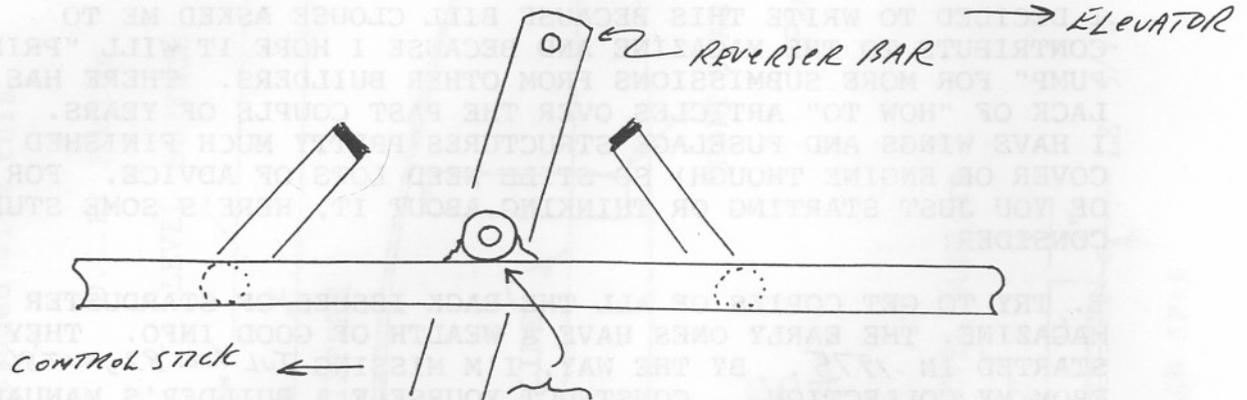
6. FOR THE ELEVATOR STOPS, MODIFIED THE DESIGN TO LOOK LIKE THIS:

ALSO, GET YOURSELF ONE OF THOSE BOLTS (FROM STARDUSTER) WITH THE GREASE FITTING INSTALLED.

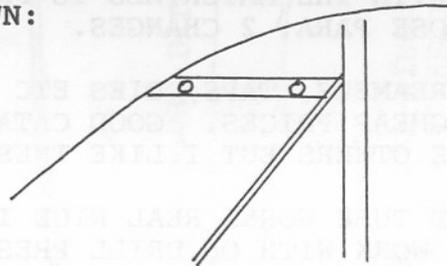
8. ON THE TAIL, MOVED THE WIRE ATTACH BUSHINGS UP INTO THE HORIZONTAL TUBE, AS SHOWN:

USED ROUND TUBE, BUT ON REFLECTION, A CONVENIENT PLACE FOR ANOTHER SQUARE TUBE TO GUARANTEE BOTH BUSHINGS AT 90 DEG TO VERTICAL.

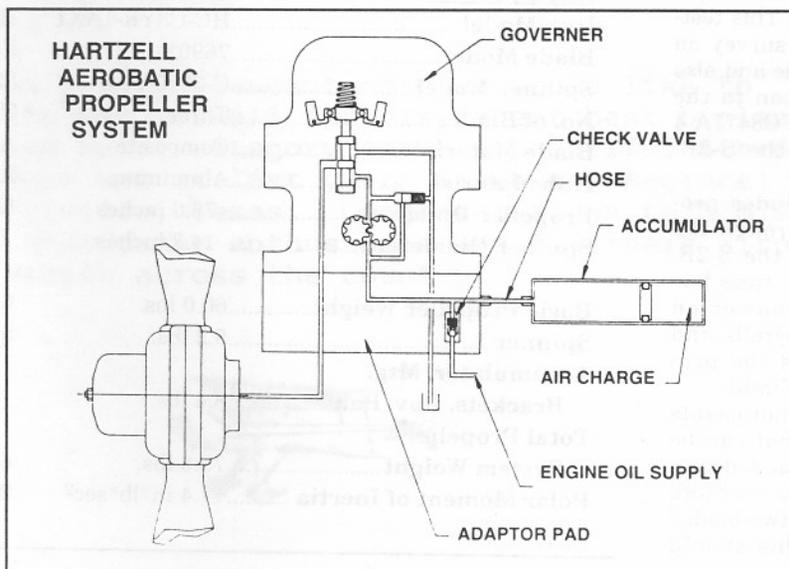
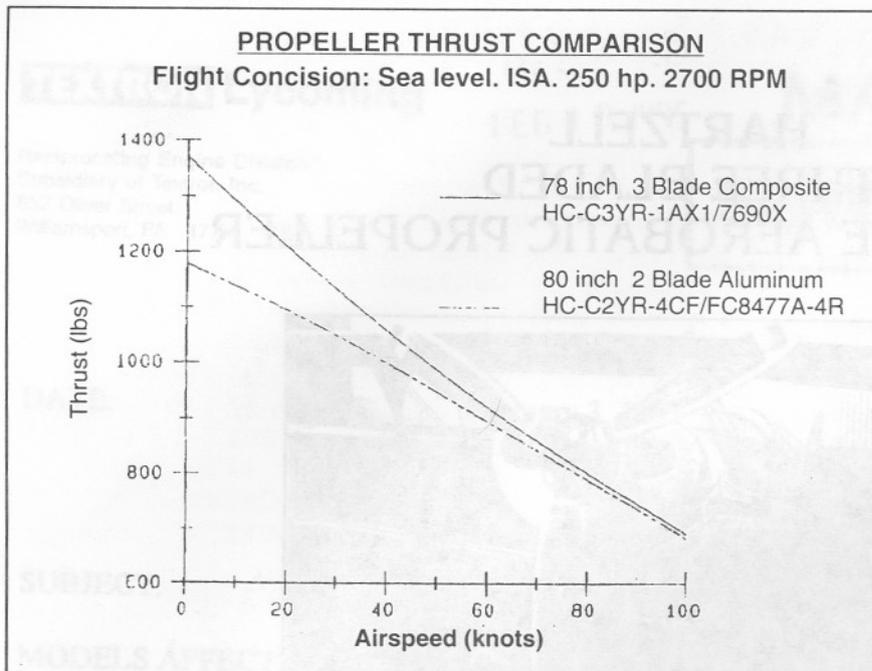
In regard to propeller overspeed, an oil accumulator system has been married to the design with the advice of John Lillberg. The system consists of a valve pad assembly between the engine oil supply and the governor. When the valve senses an oil pressure loss from the engine, the accumulator takes over, continuing to supply the governor with oil. The accumulator is mounted on the engine which helps to further reduce weight that was formerly

located out at the propeller cylinder with the nitrogen, air charge system.
