**Starduster**  
MAGAZINE

**April**  
**1996**

Prez's Comments

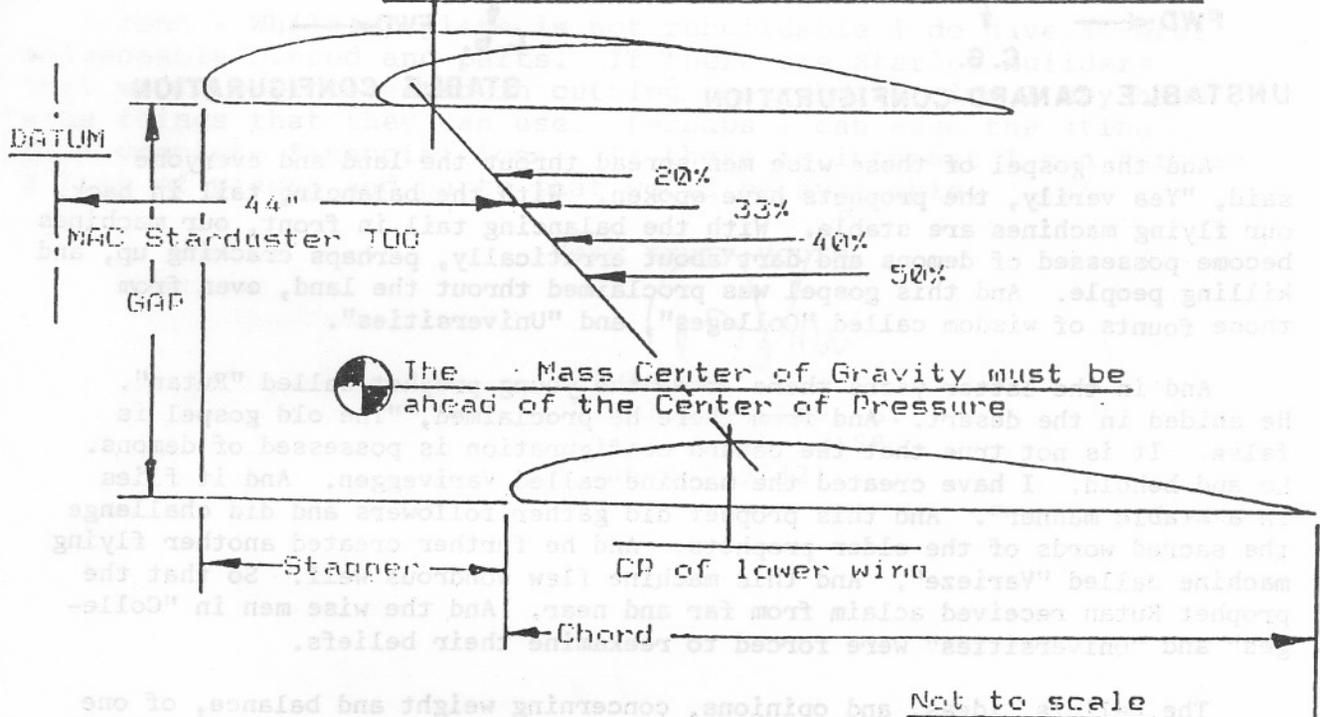
EXAMPLE #2

20% down from the upper wing which generally results in a more nose-heavy condition.

33% down from the upper wing which generally results in a more neutral condition.

40% down from the upper wing which generally results in a more tail-heavy condition

CP of upper wing taking into consideration 6 degree sweep

Not to scale

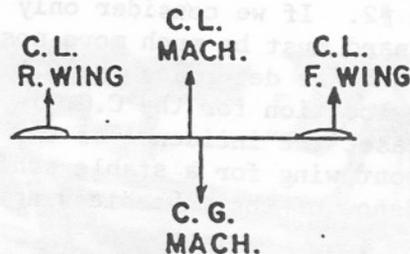
# 1.

Consider the following theoretical machine. Postulate two wings, identical, in size and shape, connected by a line, both wings with the same amount of incidence.

It is obvious that each wing has a center of lift, and the center of lift of the entire machine is exactly halfway between the C.L. of the front wing, and the C.L. of the rear wing. To be stable, the center of gravity should be in front of the C.L. machine. Note that the C.G. can be considerably aft of the trailing edge of the forward wing, and the machine is still stable. Placing the C.G. in front of the C.L. machine means the incidence of the rear wing must be decreased. This means the front wing carries more of the load. Moving the C.G. forward to the C.L. of the front wing means it carries all the load. Moving the C.G. in front of the C.L. of the front wing means the back wing has negative lift. The front wing carries more than the weight of the airplane in level flight. It must support the download of the back wing as well as the weight of the airplane. This is the way many horizontal tails function. It is obvious that the farther the C.G. is moved forward, the faster the stall speed, the slower the climb, and the slower the cruise speed. For max performance the C.G. should be right on the C.L. for the entire machine. This will make the airplane tend to porpoise in level flight, and is a good reason for keeping the C.G. slightly forward.

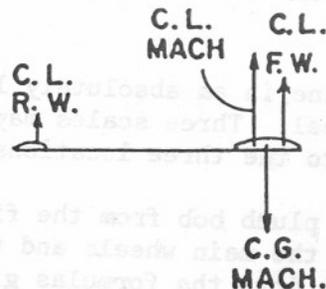
# 2.

Now postulate a conventional configuration. The front wing is considerably larger than the rear wing.

We can see that, with equal incidence, the C.L. of the machine is still behind the C.L. of the main wing. Putting the C.G. in front of the C.L. of the machine requires the rear (small) wing to have less incidence and less lift. Putting the C.G. in front of the C.L. of the main wing again requires negative lift from the small rear wing. Again, performance suffers, although not as much as in the first situation.

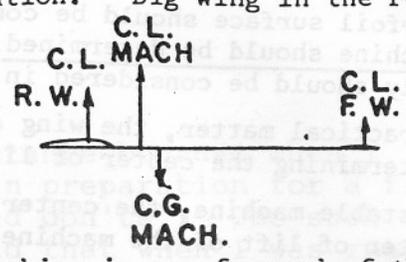
#3.

We can see that the C.L. of the machine is now forward of the leading edge of the main wing. Putting the C.G. forward of the C.L. MACH means we have a weight and balance situation which appears drastically different from situation #2. If we consider only the main wing, in each case, it appears that a canard must be much more nose heavy than a conventional airplane. However, when we determine the C.L. of the machine, in each case, the most desirable location for the C.G. is just slightly forward of the C.L. machine. In each case, the incidence of the rear wing must be less than the incidence of the front wing for a stable configuration. And as the C.G. shifts around, the incidence of the moveable wing must change, to maintain a level flying attitude.

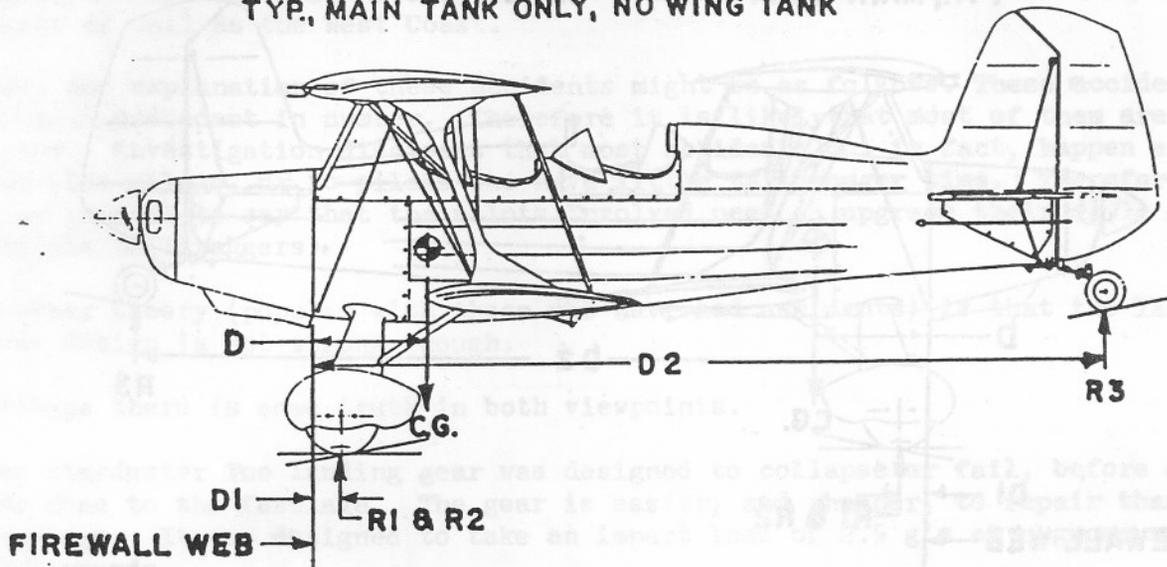
STARDUSTER TOO SA300  
 WEIGHT & BALANCE  
 TYP, MAIN TANK ONLY, NO WING TANK

HORIZ. DATUM: TOP LONGERON - SHOULD BE LEVEL  
 VERT. DATUM: FIREWALL WEB  
 FWD C.G. LIMIT: 18.0  
 AFT C.G. LIMIT: 27.0

EMPTY WEIGHT C.G. (INCLUDES ENGINE OIL)

1. The center of gravity limits are from 18 inches aft of the firewall to 27 inches aft of the firewall.
2. Main fuel tank 30 gal., 28 useable; wing tank 15 gal., 14 useable.
3. Mean aerodynamic chord is 44 inches aft of the datum.
4. The center of gravity location of the wing tank is approximately 19 inches aft of the datum.
5. The tail weight, with the latest landing gear and engine mount in level attitude, should be around 65 to 100 lbs. on all models.
6. As the fuel in the main tank burns off, the center of gravity moves aft.

Drop a plumb bob from the firewall. Measure the distance from the fire wall web to the main wheels and to the tail wheel. Plug these weights and measurements into the formulas given below, and you can determine the exact C.G. location of your bird. The closer you are to the Aft C.G. limits, the better your bird will perform. Approach the forward C.G. limit and you will have a very stable machine. Make your first flight with the horizontal tail level with the top longerons, and the trim tab in neutral. If you have to hold forward stick, increase the incidence in the horizontal tail. Decrease the incidence if stick back pressure is required for level flight.

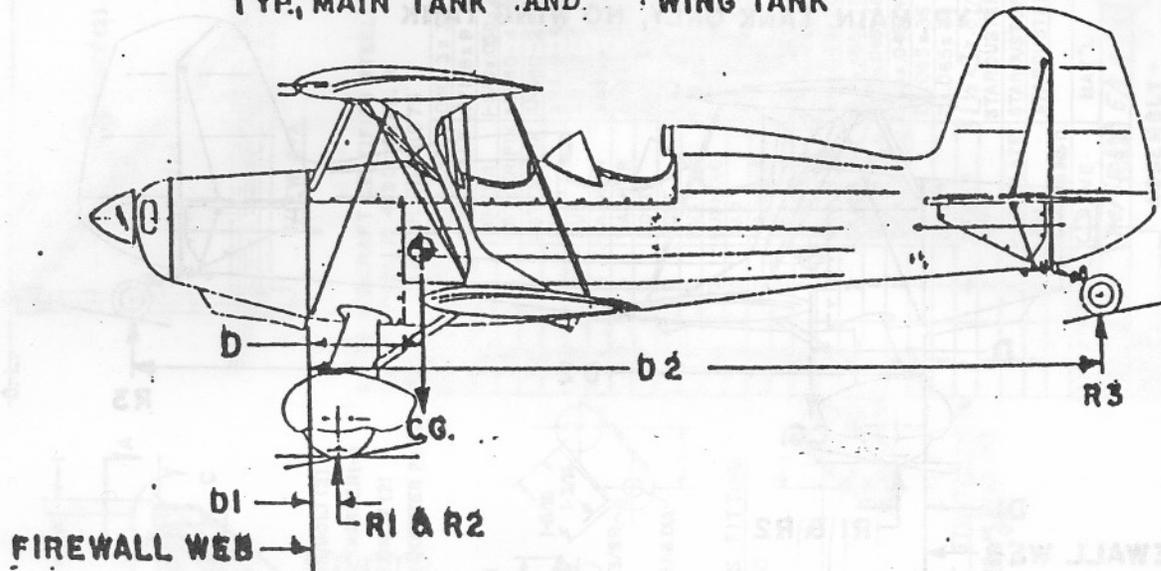
STARDUSTER TOO SA300  
 WEIGHT & BALANCE  
 TYP. MAIN TANK AND WING TANK

HORIZ. DATUM: TOP LONGERON - SHOULD BE LEVEL  
 VERT. DATUM: FIREWALL WEB  
 FWD C.G. LIMIT: 18.0  
 AFT C.G. LIMIT: 27.0

EMPTY WEIGHT C.G. (INCLUDES ENGINE OIL)

Aircraft already built should be changed if at all practical, or operated with care, taking these conditions into consideration. Several different weight and balance combinations should be worked - most forward, most aft; with or without a passenger; baggage and fuel. Refer to sample weight and balance sheet included with this article. (Example #1)

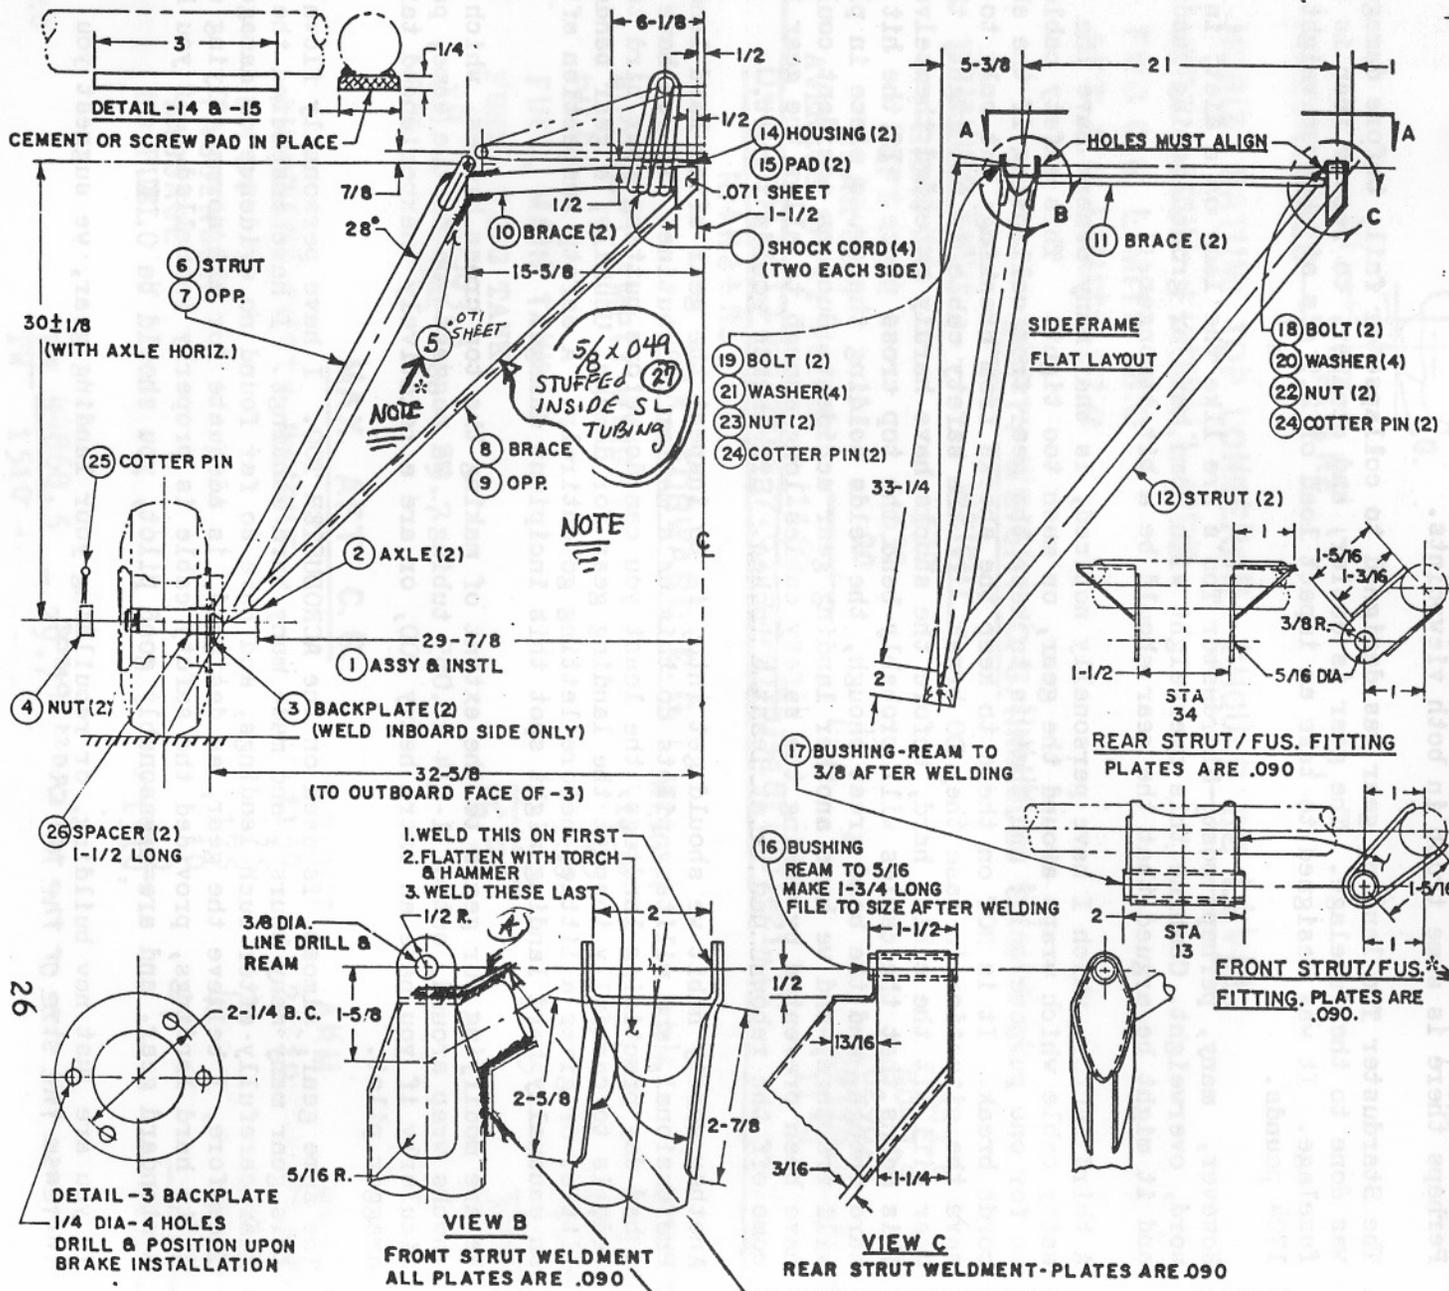
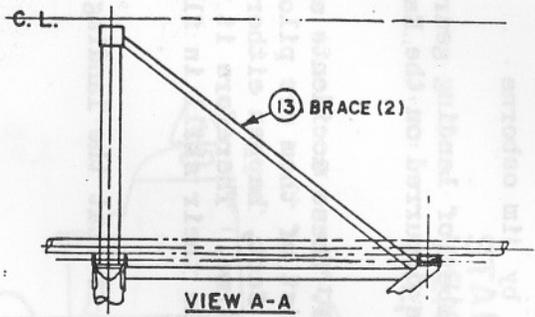
STARDUSTER  
"TOO"  
SHEET NO. 14

# NEW MODS ON LANDING GEAR

\*-DENOTES CHANGE - CAUTION SAFETY CABLE MUST ALLOW 4" OF GEAR TRAVEL

Regarding the landing gear problems on the Starduster Too, we have had several reports of landing gear failures this past year. There are three basic things that lead to gear failure. 1. Cold or poor welds 2. Gear not modified to the latest drawing 3. Damage due to a prior hard landing that has gone unnoticed. The gear generally fails in one of two situations. The first is by dropping the airplane in from about 3 feet or more. This will generally bend, stretch, or crack the gear, or bungee truss, and may not be obvious and could fail sometime later. The second is by letting the airplane get away from you during roll out. Such as in a ground loop or anytime the airplane gets sideways. This generally results in the gear collapsing under the airplane and failing at the diagonal stream line tubing under compression, and at the bungee tube and upper attach point on the main gear leg. and if you have the old style gear the results can be much worse Included in this issue is a copy of the latest gear modifications, along with my suggestions Also in this issue is an article by Jim Osborne regarding gear failure that talks about these very things.
