Starduster

MAGAZINE

Dedicated to the
 ACTIVE Homebuilders

JULY 1992

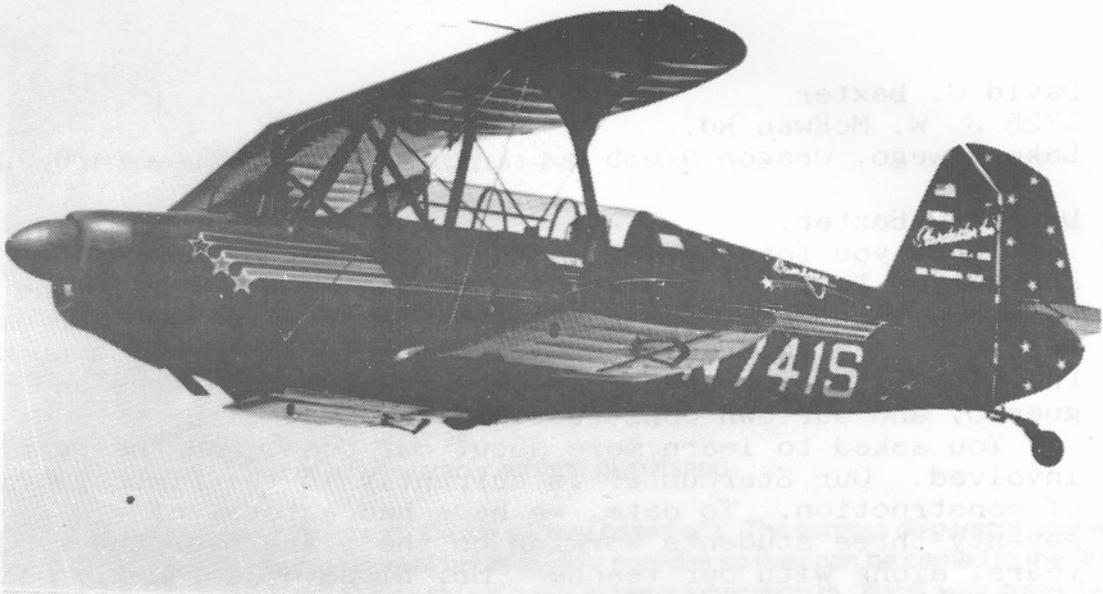
Dennis Slavick's "mystery" Starduster is one-of-a-kind, with its retractable landing gear.

Jack Swan owned this airplane for several years, and in the late 1970's or early 1980's I believe it was sold to Dennis Slavic of Crystal Bay Nevada, who also flew for Flying Tiger Air Freight. The airplane has set for many years and has just recently re-emerged. At the Tahoe Truckee Airshow in June of 91. It looks as if it has been totally refurbished, recovered and repainted. To my knowledge it has attended no other fly-ins. Dennis is an interesting individual in that I have been trying to get information about his airplane for sometime. But so far none of my letters or calls have been answered. I'm not even sure the airplane has ever flown again, perhaps this article will stimulate him into supplying some current pictures and details. I only saw this airplane at Santa Paula in late 1969. It was then sporting the original Starduster paint scheme. It was something to see, and that is the story of N741S the only SA-300 RG.
